LEAK REPORT

Leak #:	1
Date:	December 8, 2021
Map #:	N/A
Coordinates:

Leak Type	SERVICE LINE
Leak Address	339 HENLEY HORN BROOK RD

Client:	Pace Engineering / Hornbrook CSD	Agreement:	21071
---------	----------------------------------	------------	-------

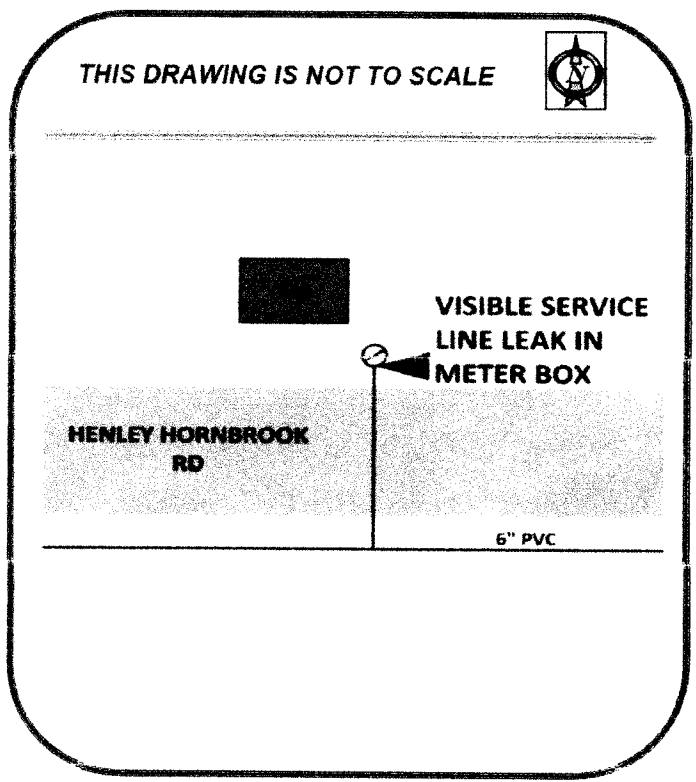
REMARKS
VISIBLE SERVICE LINE LEAK JUST UNDER CURB STOP.

LEAK INFORMATION	
Leak Consultant:	BH
Leak Class:	II
Leak Rate (GPM):	2.00
Cover Type:	METER BOX
Site Marked:	NO
Mins. Pinpointing:	20

Water Loss (gallons)	
Daily:	2,880
Weekly:	20,160
Monthly:	87,600
Annual:	1,051,200

Action(s) Taken: _____
 Recommendation(s): REPAIR / REPLACE
