LEAK REPORT

Leak #:	1
Date:	December 8, 2021
Map #:	N/A
Coordinates:

Leak Type	SERVICE LINE
Leak Address	339 HENLEY HORN BROOK RD

Client:	Pace Engineering / Hornbrook CSD	Agreement:	21071
---------	----------------------------------	------------	-------

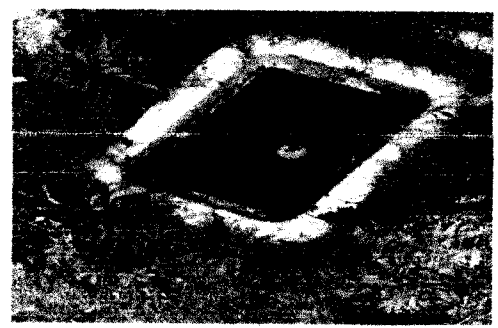
REMARKS
VISIBLE SERVICE LINE LEAK JUST UNDER CURB STOP.

LEAK INFORMATION	
Leak Consultant:	BH
Leak Class:	II
Leak Rate (GPM):	2.00
Cover Type:	METER BOX
Site Marked:	NO
Mins. Pinpointing:	20

Action(s) Taken: _____
 Recommendation(s): REPAIR / REPLACE
